LAWRENCE  
LIVERMORE  
NATIONAL  
LABORATORY

UCRL-TR-231591

# Facility Modernization Report

# Facility Modernization Pilot Study

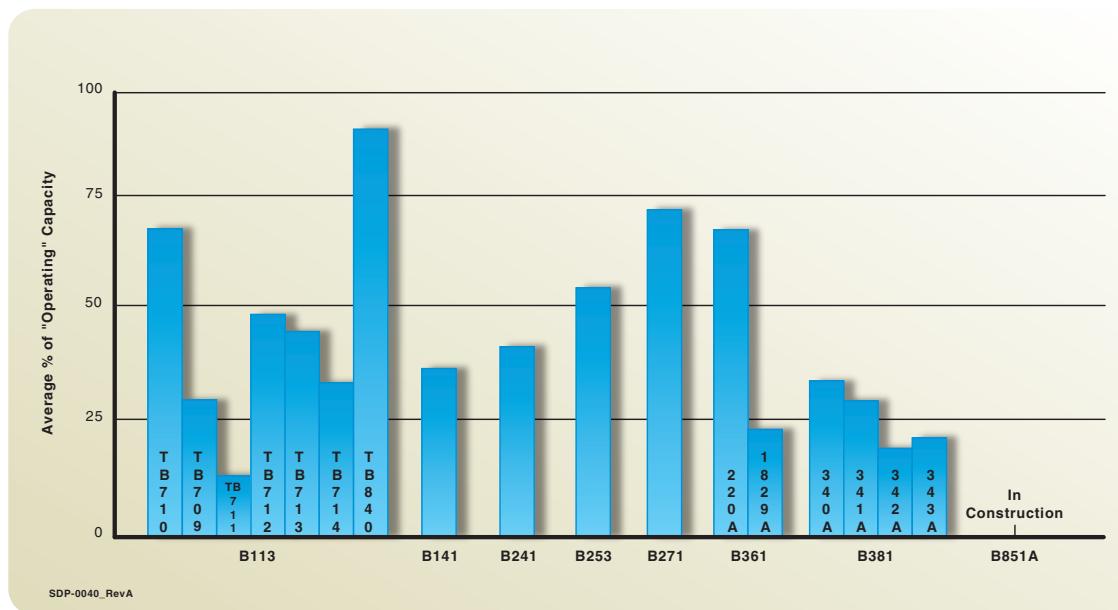
**Figure 2.** Low-voltage electrical system main circuit breaker operating loads at 80% of nameplate capacity.

Discussion of Findings. Measurements of usage (kw/h) and amperage were taken at each of the facilities to determine average and peak operating loads. Refer to Figure 2 for a summary of the main circuit breaker(s) operating loads, expressed as 80% of nameplate capacity for each facility. Only one of the loads (B113, TB840) exceeded the breaker's desired (internal LLNL standard) operating capacity. No loads exceeded the main breakers nameplate capacity. The load at B113 will be significantly reduced as computational capability is shifted to the newly constructed Terascale Simulation Facility (TSF).

- **Conclusion.** The capacity of the main circuit breakers was found to be adequate. Replacement of the old style main breakers with multiple trip setting units would provide more flexibility and improved coordination of low voltage electrical distribution systems.
- **Recommendation.** Replacement of minimum/maximum setting breakers with multiple trip setting breakers, when properly configured, would improve reliability, operation, and breaker coordination.
